REPORT NUMBER: SINCAP-CAL-20-007

NEW CAR ASSESSMENT PROGRAM (NCAP) MOVING DEFORMABLE BARRIER SIDE IMPACT TEST

Ford Motor CO. 2020 Ford Explorer SUV

NHTSA No: M20200205

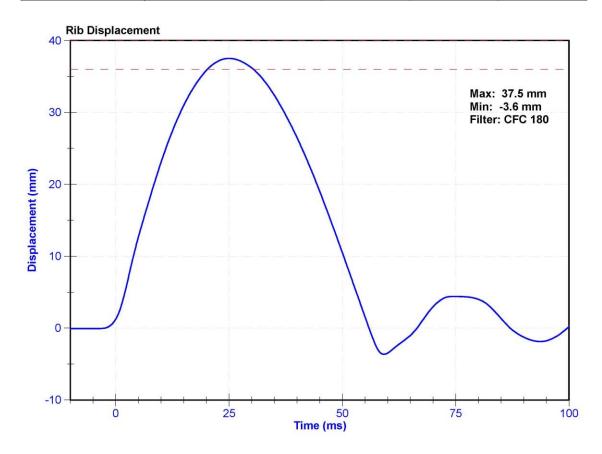
Certification Report ES-2re Upper Rib Drop 4 m/s - CFR 572

Test Parameter	Minimum Specification	Maximum Specification	Unit	Result	Pass/Fail
Temperature	20.6	22.2	°C	21.3	Pass
Humidity	10	70	%	29.3	Pass
Rib Displacement	46	51	mm	48.1	Pass
